ASIA TURBOMACHINERY & PUMP SYMPOSIUM
MARCH 2018 | SUNTEC SINGAPORE

Operating with a broken pinion teeth
By
Vasanth Bhat & Keith Loh
Singapore Refining Company Pte. Ltd.

Hydrocracker Feed Pump Gear Box

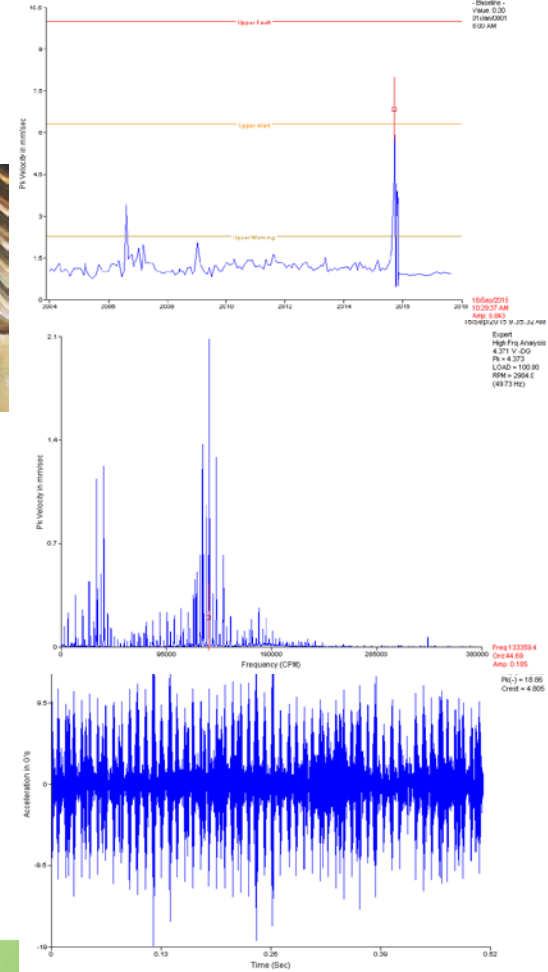
- Abnormal noise was observed in one of the pumps and appeared to be from the gearbox.
 - A significant increase in vibration was observed at the gearbox .
 - The spectrum showed up gear mesh with sidebands and multiple harmonics pattern similar to looseness.
 - The time waveform showed multiple impacts indicating potential of broken tooth.
 - Pump was shutdown and gearbox was opened up for inspection. Found two teeth on the pinion broken. Pitting observed on other teeth.
-

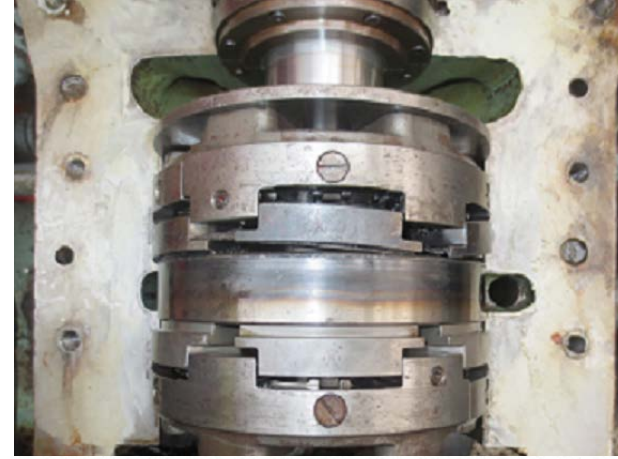
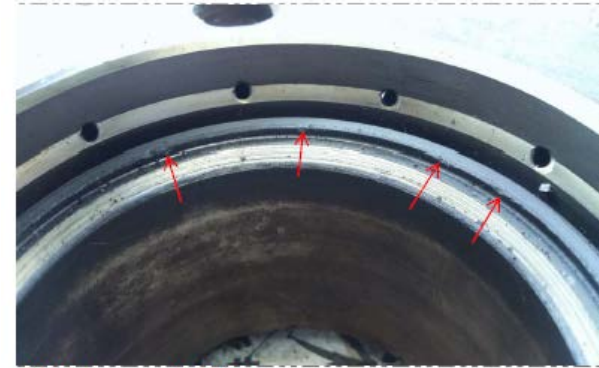
P/N: 3-1

- The previous inspection history of the gearbox did not indicate any abnormality.
- Due to the edge loading on the gearbox teeth the pump side was inspected and found that the thrust float was abnormal.
- Further inspection revealed the thrust bearing was damaged.
- The shift in the pump shaft towards the gearbox caused the gearbox pinion to be misaligned ,resulting in the pinion teeth to break.
- The pump drive end mechanical seal was found with badly worn out face due to axial shift of the rotor.

Multiple chip off was found on the seal ring seal face.

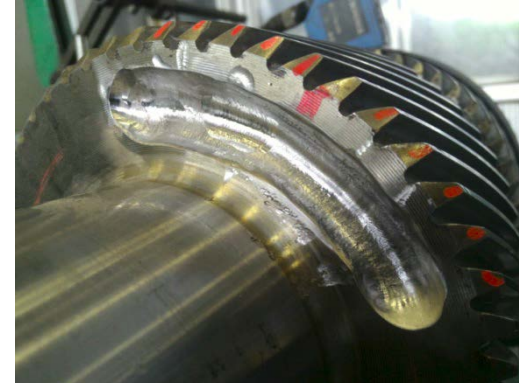
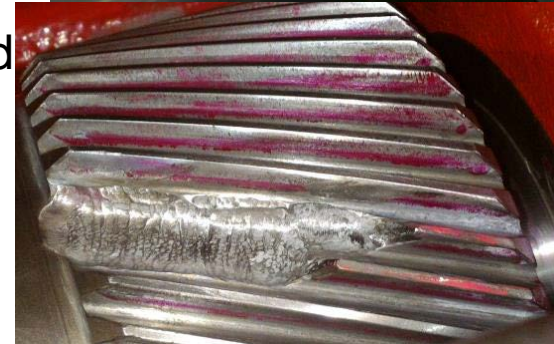
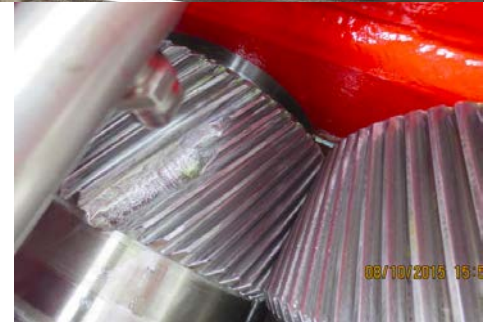
- After NDE, major length of the damaged teeth had to be dressed.
- Based on the removal of mass from the broken section, the amount of unbalance on the pinion rotor was high. Multiple areas were used to compensate for the unbalance mass so that the strength of the gear is not significantly compromised and would not become areas of major stress concentration.
- Rotors were balanced close to G1 and bearing clearances maintained in the optimum range.
- As a spare vibration monitor was available it was installed on a temporary basis with non contact probes installed at both ends of the pinion shaft with casing vibration measured in radial directions. The alarm from the monitor was connected to a DCS alarm so that the operator would get an immediate information if there was any abnormality.

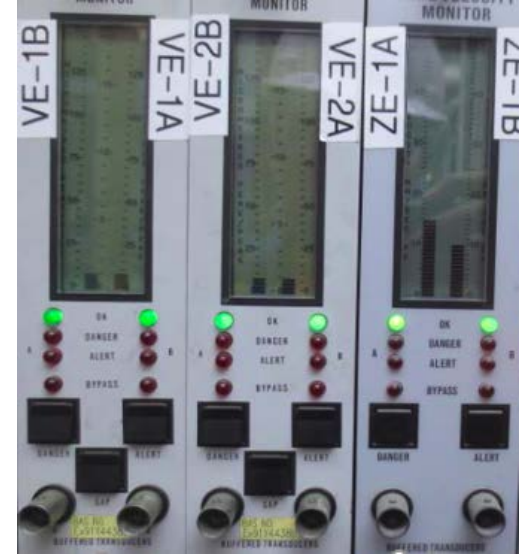
- An initial run was done without connecting to the pump and found the gearbox vibrations and noise were well within the acceptable limit.
- The pump was coupled and the train was gradually loaded up . The gear box noise levels were slightly elevated but the vibrations were well within the limits
- The pump was run back in normal operation within 20 days after the failure.
- The pump was operated with the temporary repair for another 3 weeks before the spare gear box was received.
- The complete gearbox was swapped but no major damage observed on the pinion shaft when removed.
